Gerard v. Omega Flex

March 20, 2016

Executive Summary

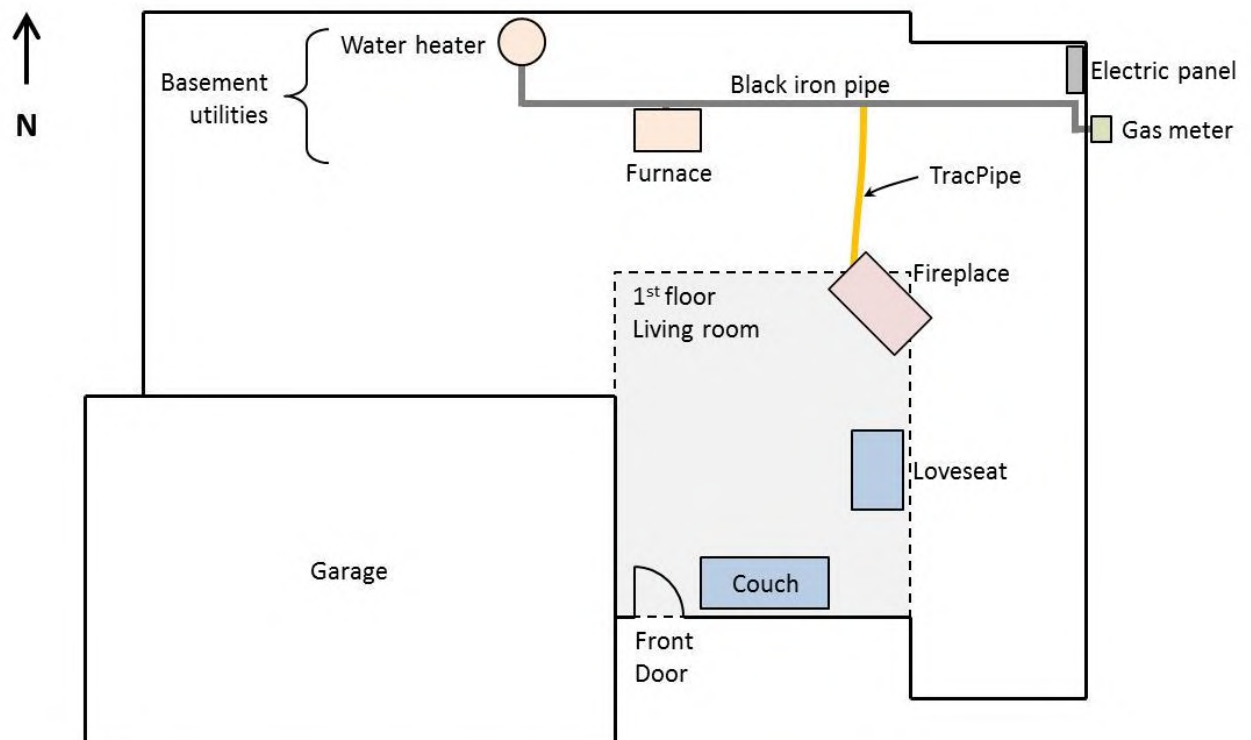
A layout of the first floor living room with the fireplace and a schematic diagram of the utilities is shown in Figure 3. The home was supplied with natural gas at the northeast corner. Black iron pipe was used to connect the natural gas supply to a water heater and a furnace in the basement. A section of ½" nominal TracPipe CSST connected to a tee in the black iron pipe supply piping and ran along the basement ceiling to the bottom of the fireplace in the first floor living room. The TracPipe CSST connected to a flexible gas connector, which was connected to the gas valve in a compartment underneath the fireplace, as shown in Figure 4.

Figure 3. Schematic diagram of the Gerard residence showing utility locations in the basement and the configuration of the living room. Not to scale.

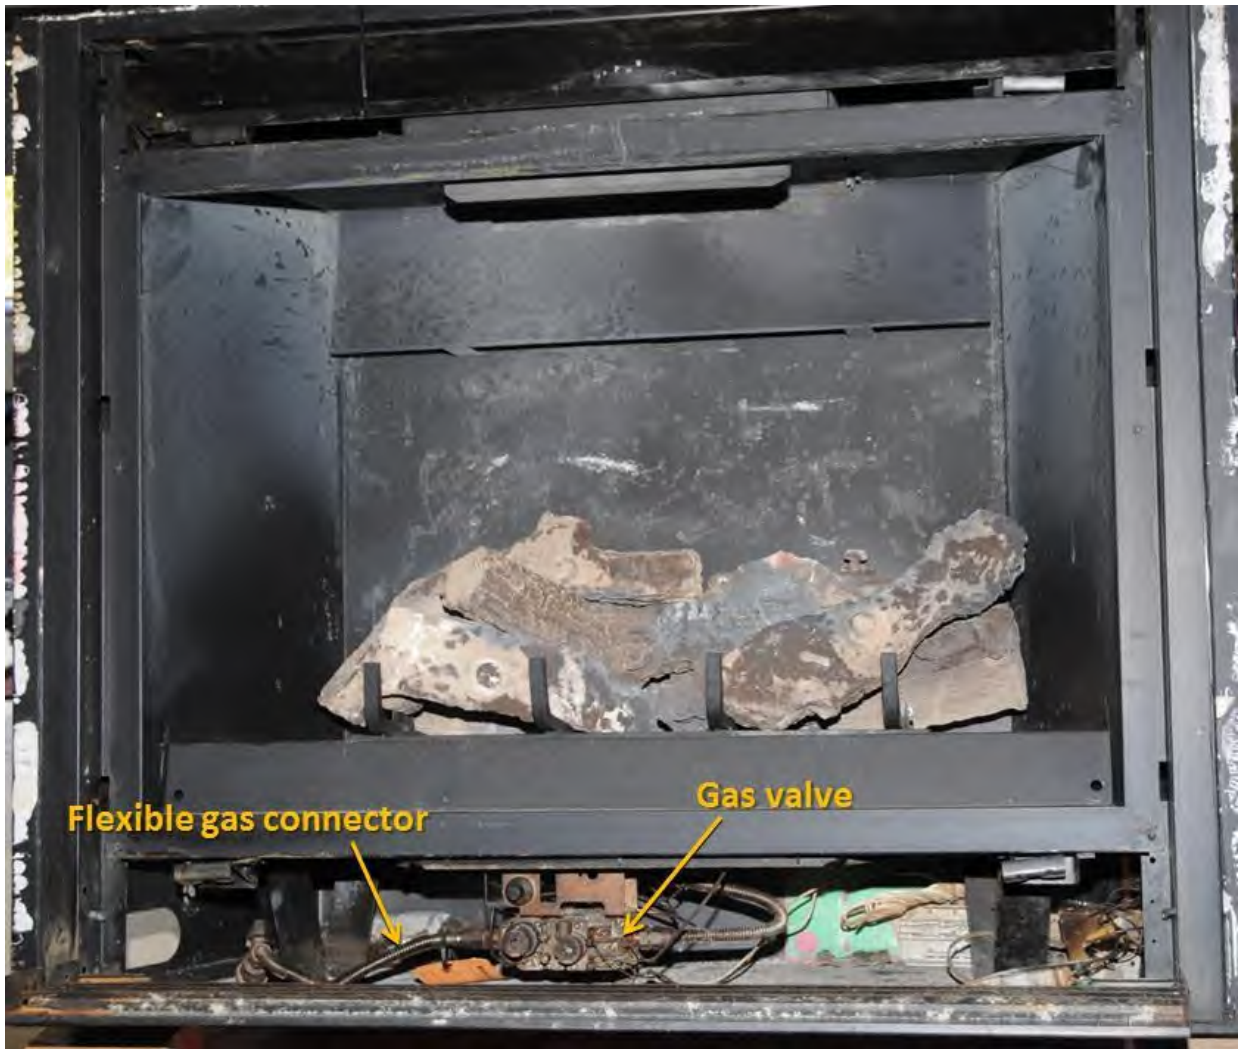
Figure 4. Photograph of the fireplace from the living room of the Gerard home.

As shown above in Figure 4, the fireplace comprised two compartments, a larger main compartment and a smaller compartment underneath with a flexible gas connector and the gas valve. There were two holes in the flexible gas connector that ran from the TracPipe CSST to the gas valve in the bottom compartment of the fireplace (see Figure 20). Both holes showed molten and resolidified metal around the edges (see Figure 21), indicating that they were caused by electrical arcing. Both holes were approximately elliptical, one had dimensions of approximately 1 mm x 4 mm, while the other had dimensions of approximately 1 mm x 3 mm.

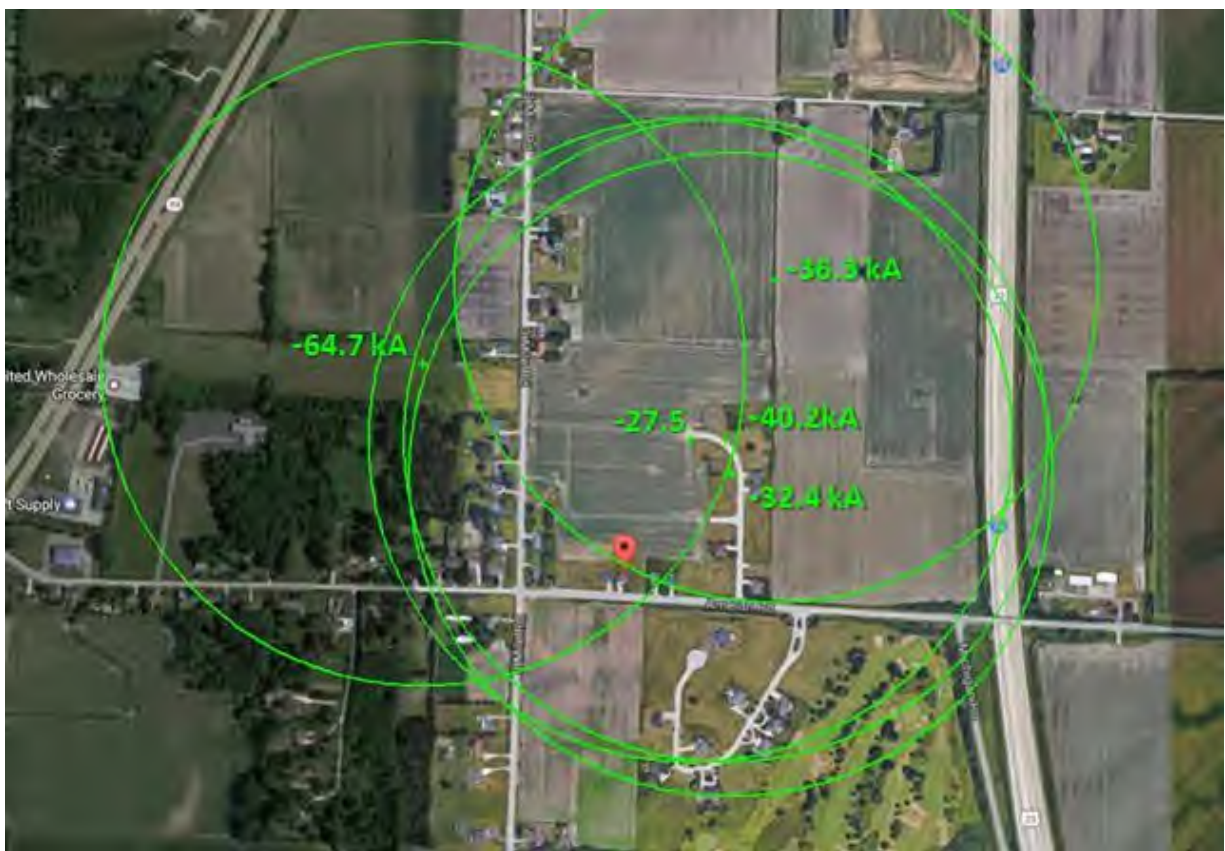
Analysis of the data and the timeline of events were used to identify the strokes that were most likely to have affected the Gerard home (see Table 1). The locations of these five strokes are shown in Figure 5. The five strokes were part of a single lightning flash at 1:44 AM.

Figure 5. Map showing the location of the five lightning strokes in Table 1 and their confidence ellipses. The Gerard residence is indicated by the red balloon.⁸

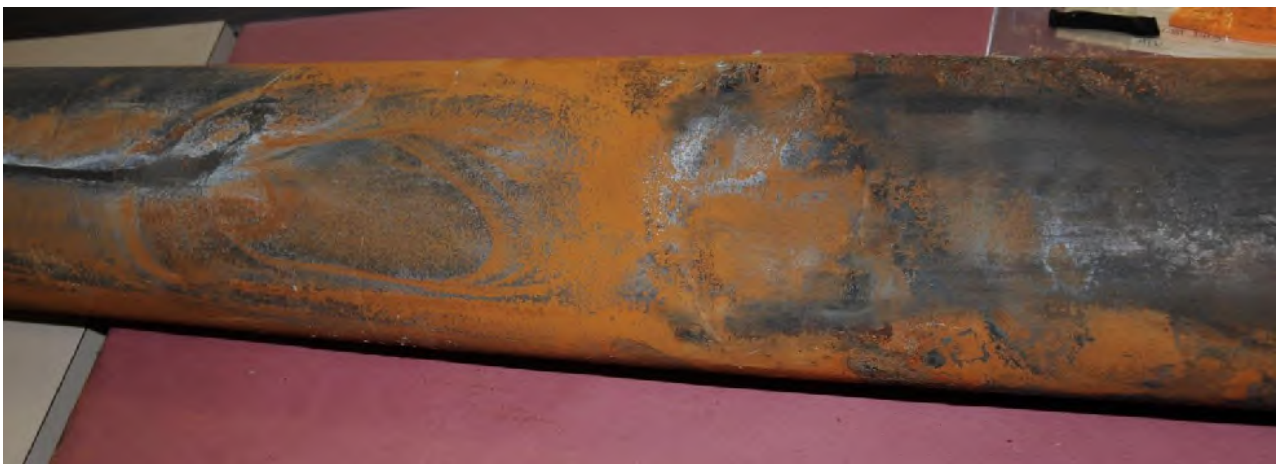
The HVAC duct that was retained ran along the basement ceiling in the Gerard home from the north side (near the furnace) toward the south side, approximately parallel to the TracPipe CSST line to the fireplace. The duct comprised two sections, shown in Figure 11 and Figure 12.

Figure 12. Photograph of the north section of the HVAC duct.

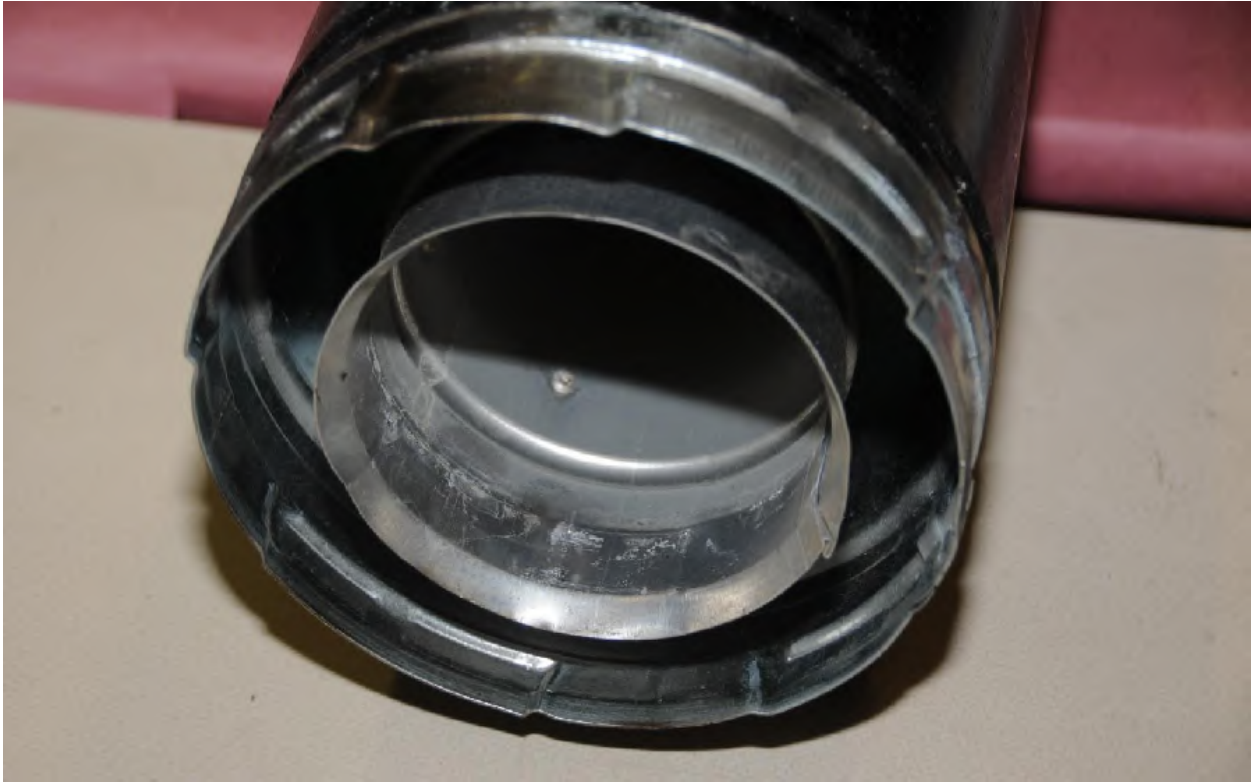
The flue pipe for the fireplace comprised multiple sections of double-walled vent piping (see Figure 14). It terminated at the top with a chimney cap (see Figure 15). There were multiple locations on the chimney cap where the metal had melted and resolidified (see Figure 16 and Figure 17). This damage indicates that lightning directly struck the flue pipe chimney cap.

Figure 14. Photograph of the double-walled fireplace flue piping.

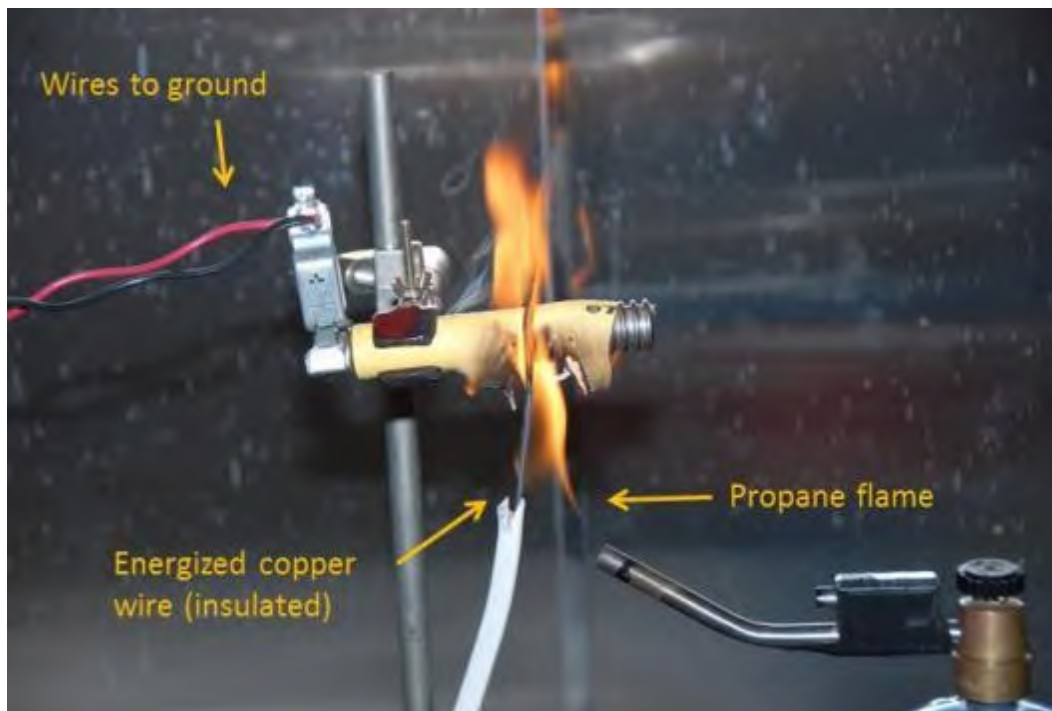
A 14 AWG branch circuit cable (type NM-B) was connected in series to a 15 amp rated circuit breaker which was supplied by a 120 VAC electrical outlet protected by a 20 amp breaker. The live (or hot) conductor was separated from the neutral and ground conductors and placed near a length of TracPipe that was connected to a grounded water pipe using a stainless steel hose clamp. The insulating jacket on both the TracPipe and the live conductor was kept intact. A propane diffusion flame was then applied under the TracPipe and live conductor. A photograph of a sample test is shown in Figure 1.

Figure 1. Photograph of the testing of TracPipe in proximity with energized branch circuit wiring in the presence of a flame.

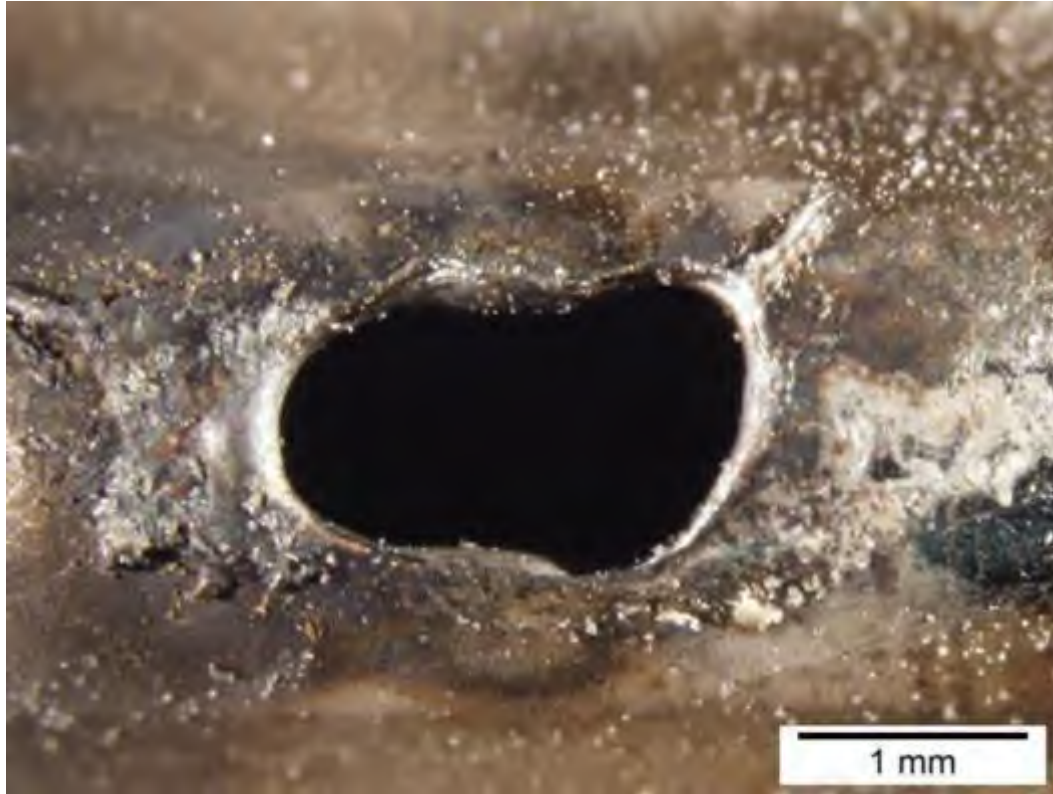
Once the insulation on the conductor and the TracPipe began to burn away, an electrical arc occurred between the conductor and the TracPipe, forming a hole in the TracPipe. An optical microscope image of one example hole from such a test is shown in Figure 2. This testing demonstrated that energized electrical wires can cause a hole in TracPipe in the presence of a pre-existing fire.

Figure 2. Optical microscope image of hole formed in TracPipe by household electricity in a flame.

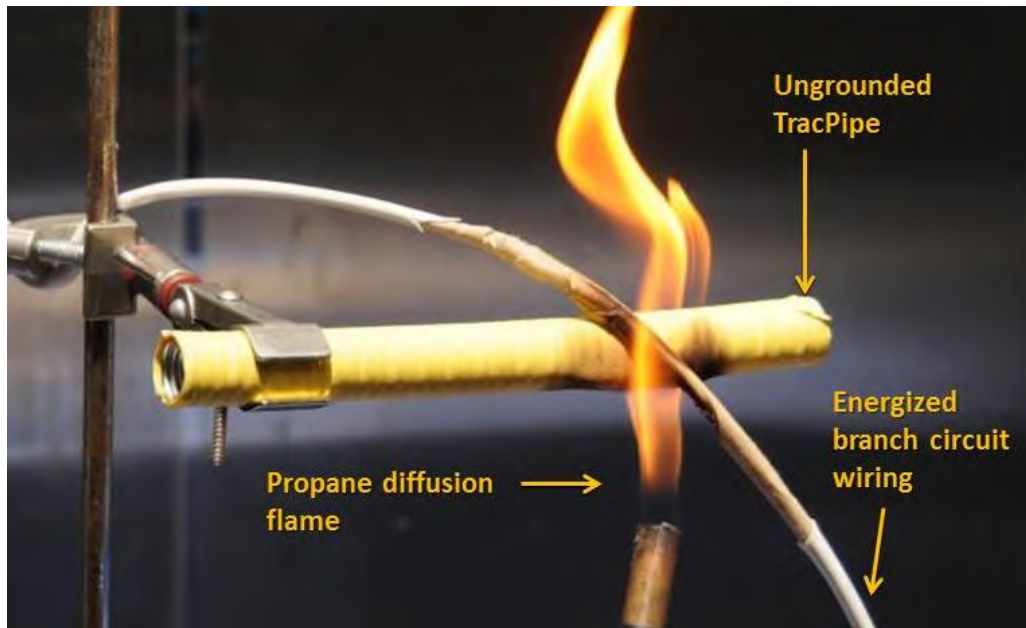
Additional testing was performed in which the TracPipe was not grounded and all three wires (hot, neutral, and ground) were electrically connected and kept in place in close proximity to the TracPipe (see Figure 3). As in the testing described above, the branch circuit wiring was energized with typical 120 VAC and a diffusion flame was placed underneath the TracPipe and wiring.

Figure 3. Photograph of testing with TracPipe and with all three conductors of branch circuit wiring.¹

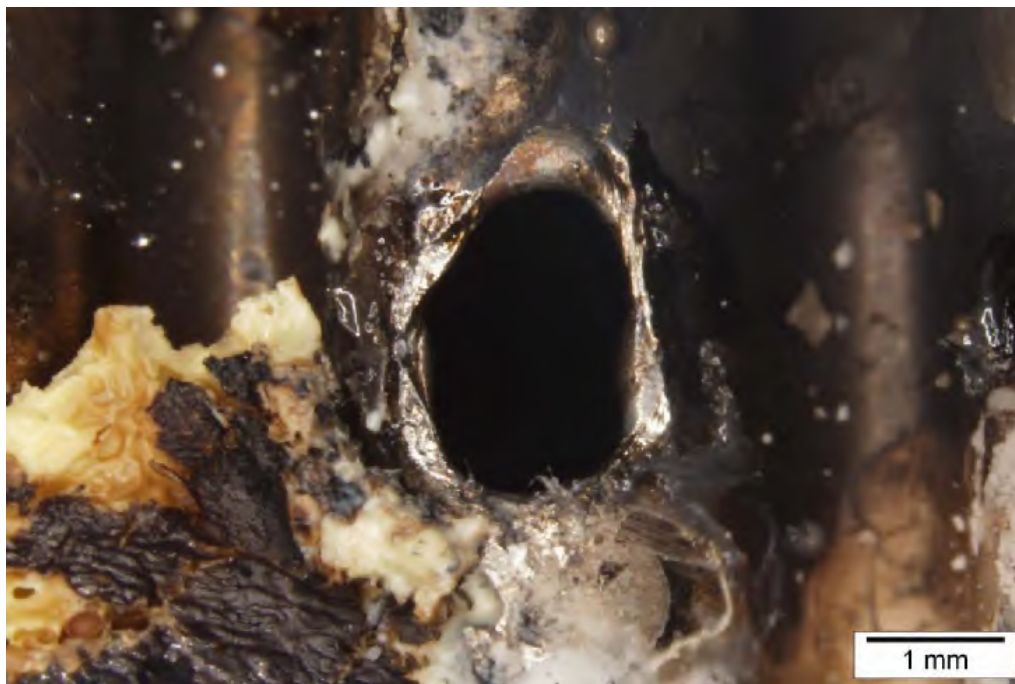
Even with the neutral and ground wires running along the hot (energized) wire, the hot wire arced to the TracPipe rather than to the neutral or to the ground, resulting in the formation of holes in the TracPipe (see Figure 4 and Figure 5). The reason arcing occurred to the TracPipe is because the fire consumed the outer portions of electrical insulation before it consumed the insulation between the individual conductors. This is likely due to the protection of the insulation material between conductors from the flame by the conductors themselves.

Figure 4. Optical microscope image of an example hole formed in TracPipe by a three-conductor branch circuit wire.

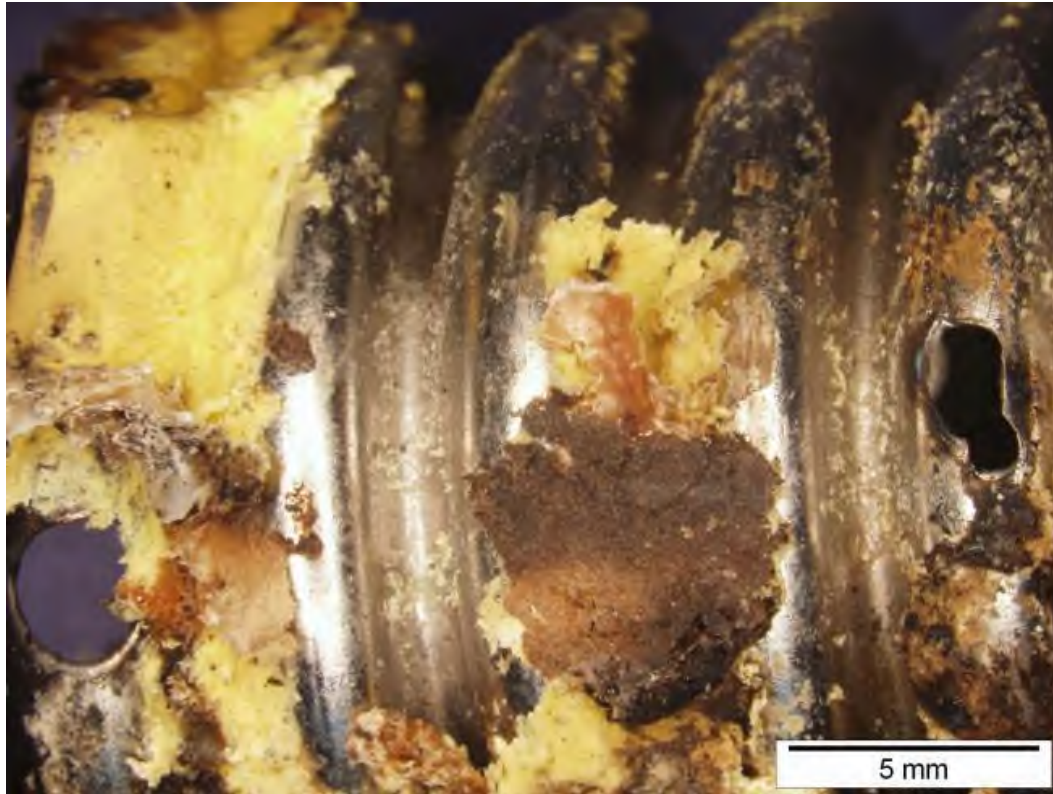
Figure 5. Optical microscope image of two example holes formed in TracPipe by a three-conductor branch circuit wire.

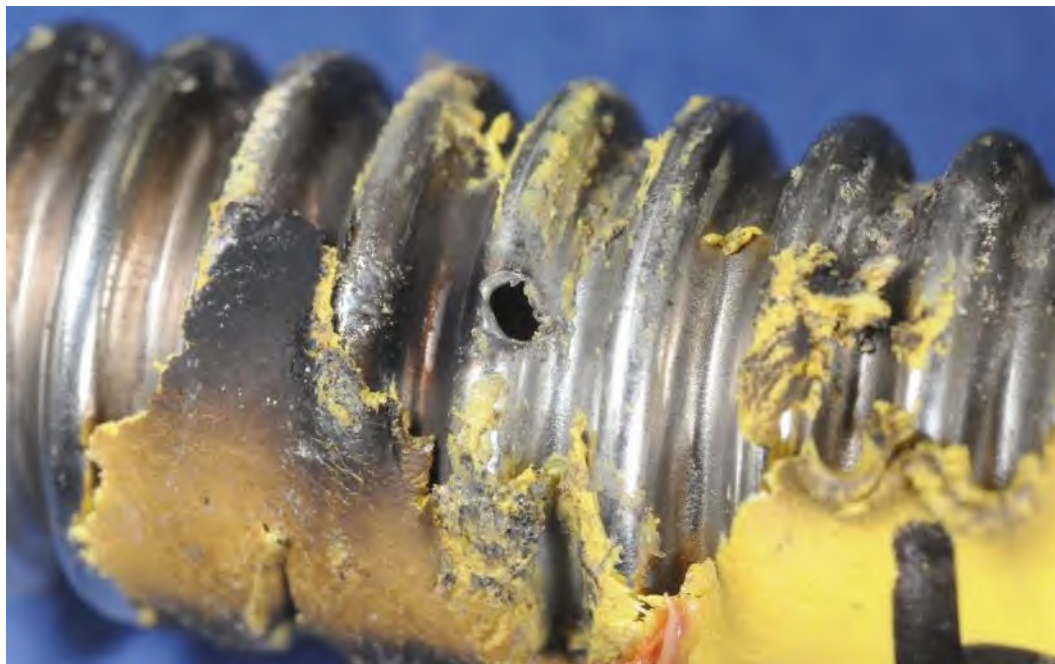
This test procedure was repeated with the resistor set to different resistances. By selecting different values of the resistance, the current that flowed through the arc could be controlled such that the circuit breaker tripped with either the magnetic or thermal mechanism. As expected, the hole size varied when the resistance (and thus the total charge transfer) was altered. Larger holes were observed with resistance values that caused the circuit breaker to trip with the slower thermal mechanism. Examples of holes from this testing are shown in Figure 8 and Figure 9 and Figure 10. These holes are irregular in shape and cross one or more corrugations of the TracPipe, exhibiting peninsulas or fingers at the edge of the hole.

Figure 8: Photograph of a hole (2 by 2 mm) in TracPipe created using a resistance of 0.15 Ω .

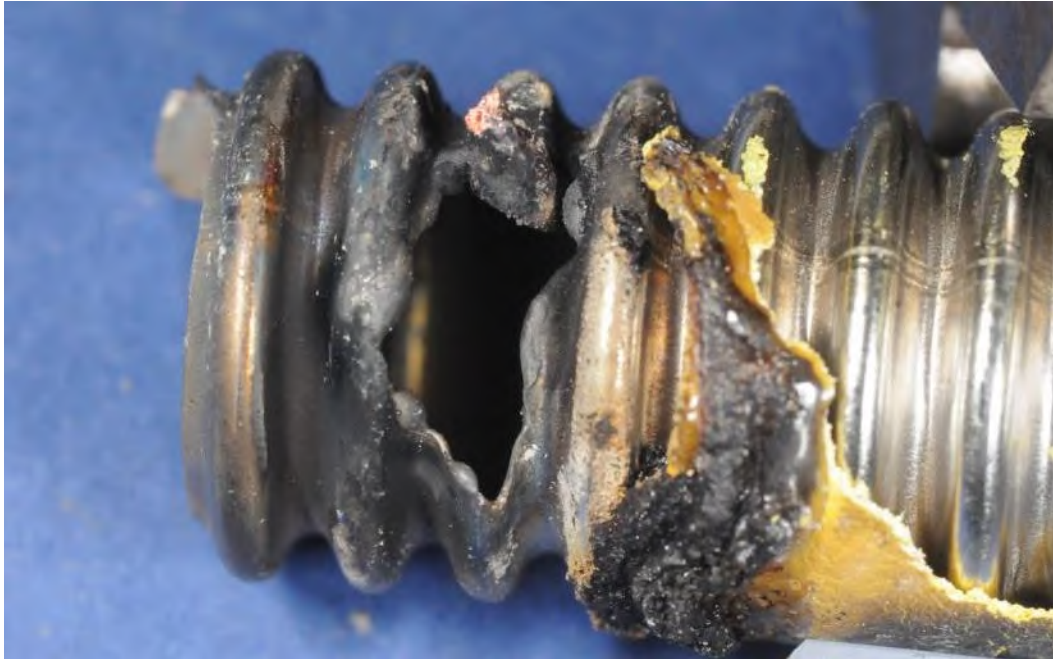
Figure 9: Photograph of a hole (10 by 6 mm) in TracPipe created using a resistance of 0.70 Ω .

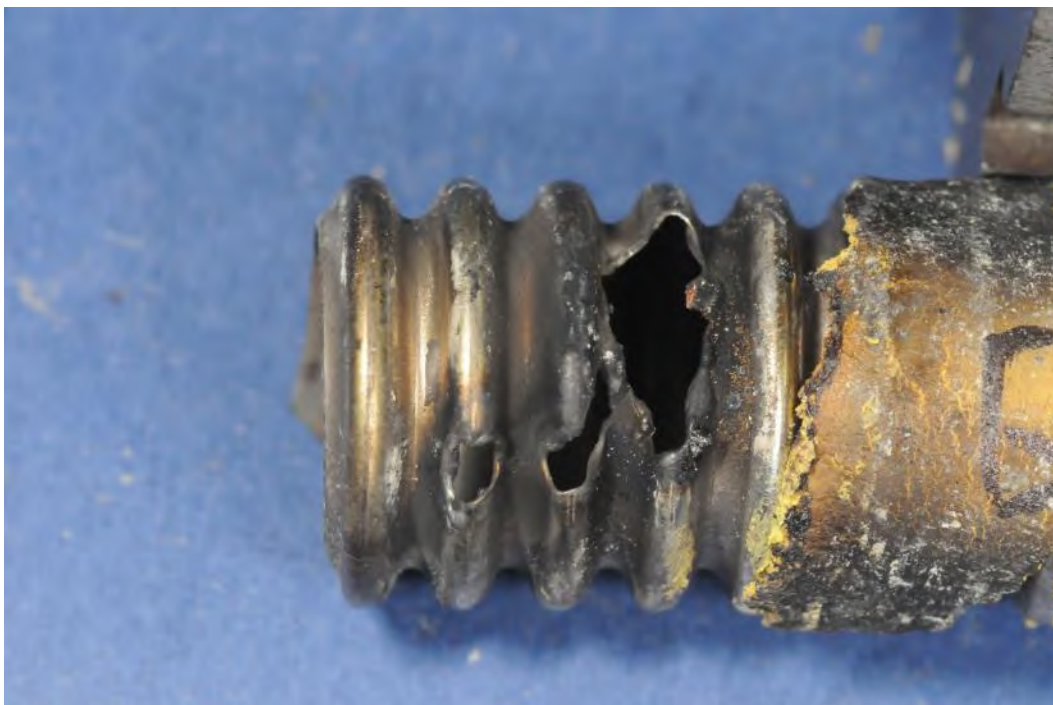
Figure 10: Photograph of three holes (4 mm by 3 mm; 6 mm by 2 mm; 11 mm by 4 mm) in TracPipe created using a resistance of 0.54 Ω .

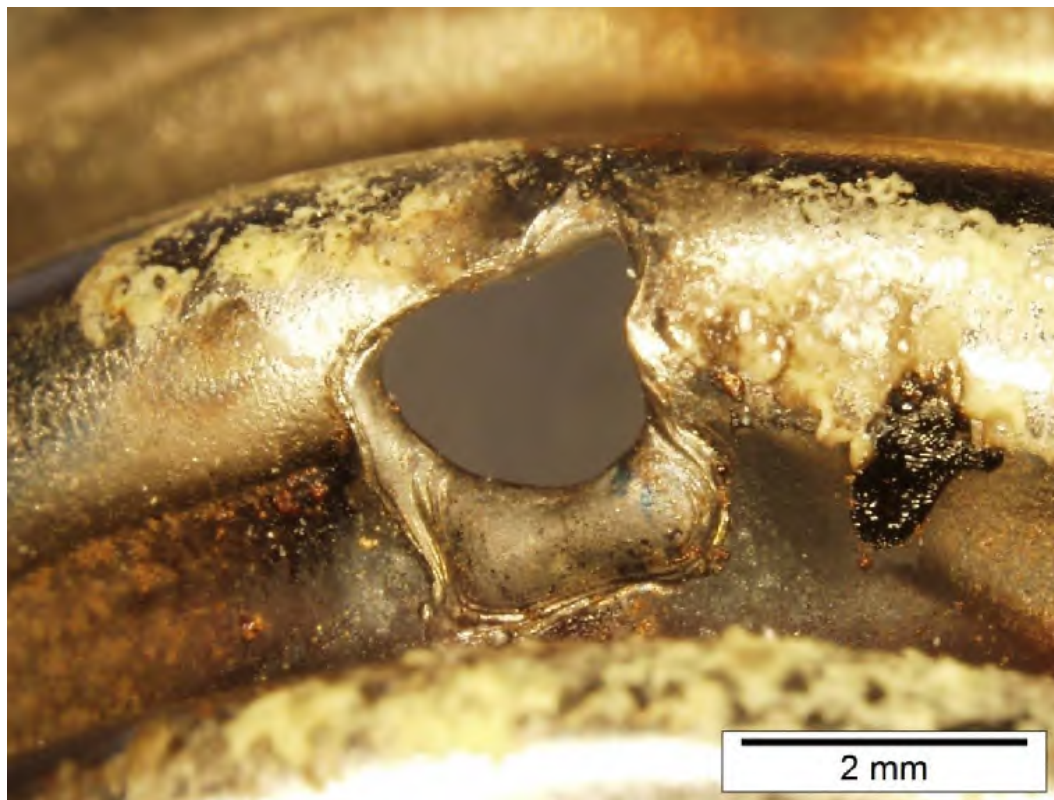
Testing with branch circuit wiring has also allowed Exponent to examine the morphological characteristics of such holes. Several examples are shown in Figure 11 through Figure 13. The character of the hole is similar to holes in TracPipe that were allegedly caused by an electrical arc due to lightning. This similarity makes it impossible to identify the source of electrical energy that caused the hole (lightning or household electricity) from an examination of the hole alone.

Figure 11. Image of a hole formed in TracPipe by household electricity in a flame.

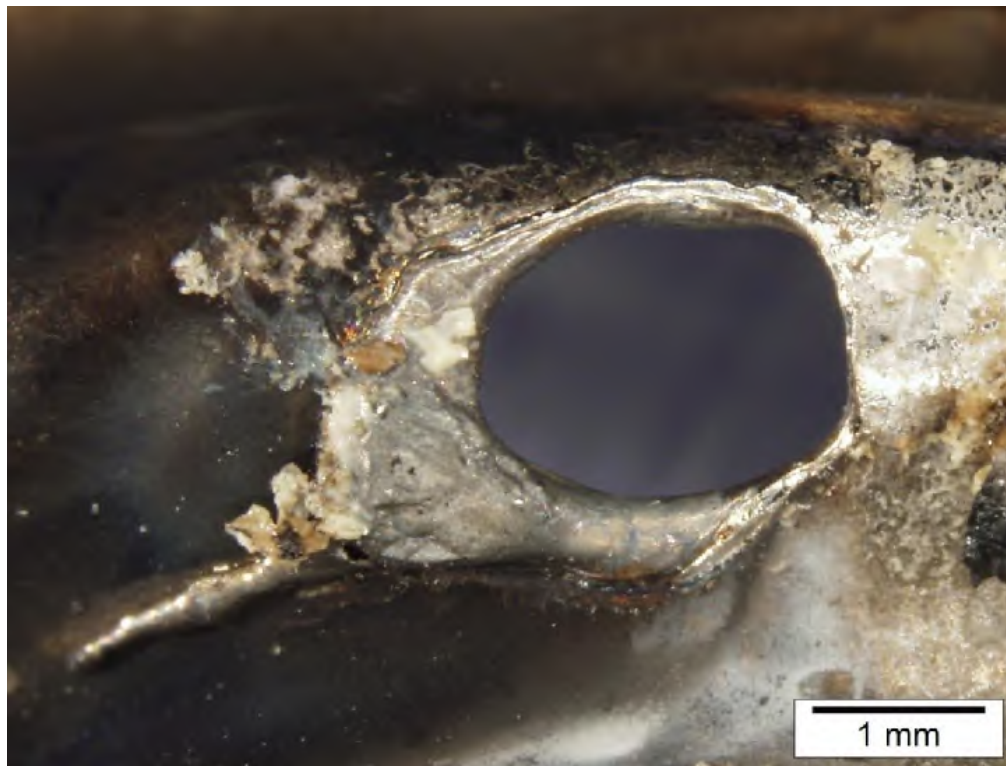
Figure 12. Image of a hole formed in TracPipe by household electricity in a flame.

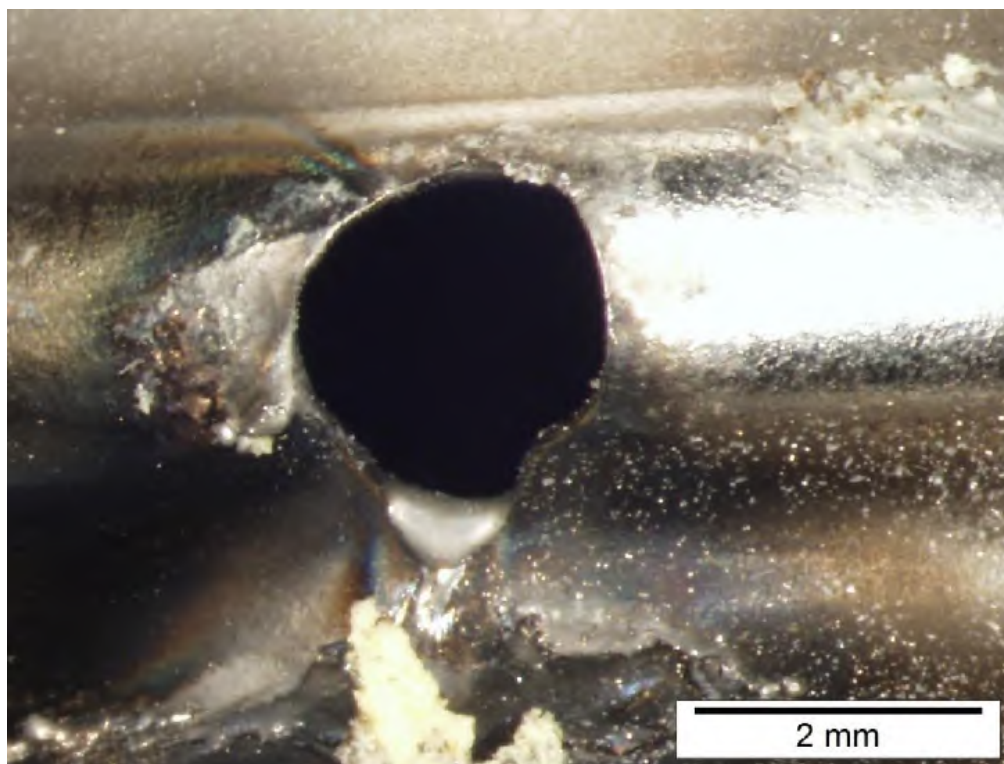
Figure 13. Image of a hole formed in TracPipe by household electricity in a flame.

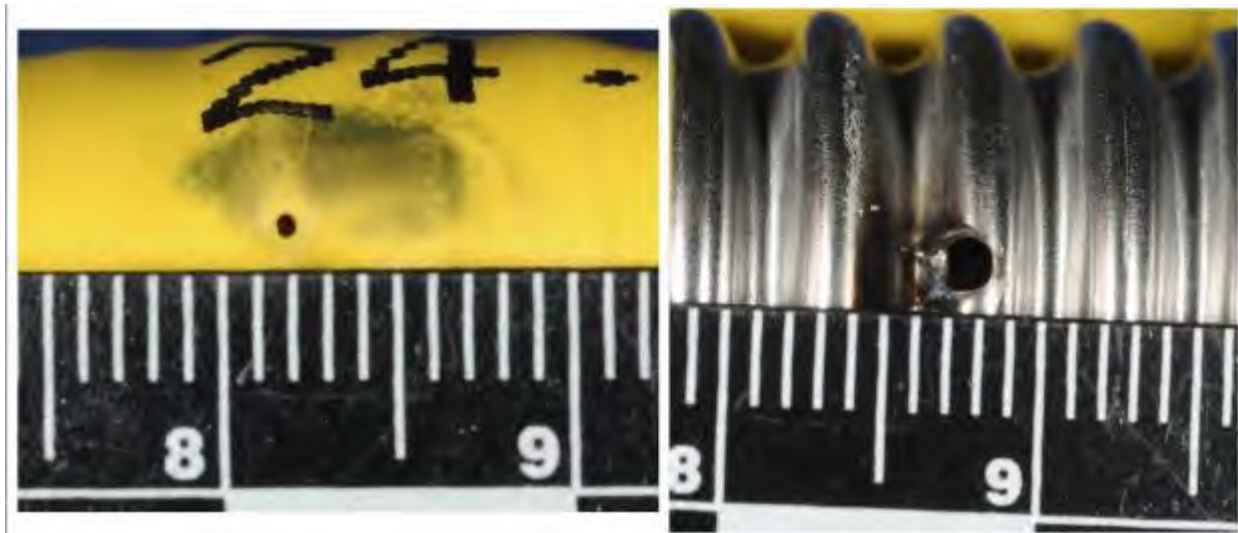
Five tests were performed. Each test resulted in the formation of a hole in the stainless steel ranging in diameter from 1 to 2 mm. Notably, the hole in the insulation after the arc formed was found to always be significantly smaller than the hole that formed in the stainless steel behind it (see Figure 4). The arcing event which caused the hole in the CSST was not able to ignite the gas escaping from the hole in any of the five tests. After the testing, a flame from a butane lighter was brought into the resulting gas jet downstream from the hole to demonstrate that the gas could be ignited by a separate ignition source, such as an existing fire. Video and photographs from this testing are included with this report.

Figure 4. Photographs of the hole in the jacket (left) and the hole in the underlying stainless steel wall (right) after an arc test. Note the ruler increments are in millimeters.
